# Manhole Inspection Summary

Manhole # S53G\_\_024MH

Insp Date: **4/14/08 1:53 PM**

**Location** Address: **200 south east street**

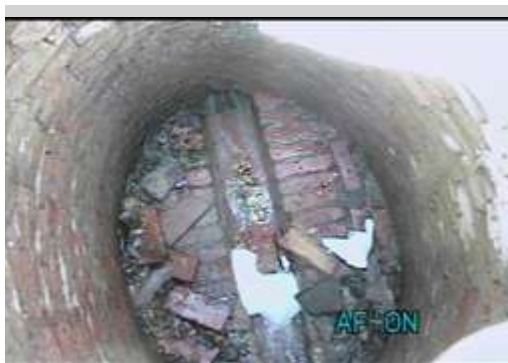
Defect 2

Condition: ☐ Sound ☐ Cracked ☐ Root Intrusion ☐ Deteriorated ☐ Leaks ☒ **Debris**

channel debris

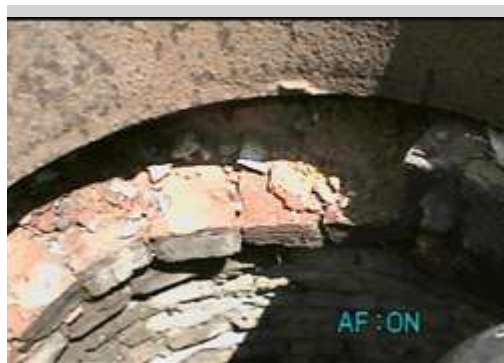
Defect 1

Condition: ☐ Sound ☐ Cracked ☐ Root Intrusion ☒ **Loose Brick** ☐ Deteriorated

chimney loose bricks

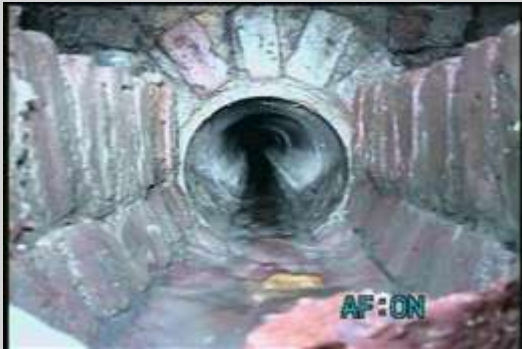
12 O'Clock Outflow

8 in. Circular Gravity Sewer  
Pipe Out @ 12 O'Clock

Pipe Material: **Clay** ☐ Pipe Lined

Invert Depth: **7.20** (ft.) Flow Characteristics: **Fast**

Deposits: ☒ None ☐ Mud ☐ Sludge ☐ Debris ☐ Grease

Infiltration: **None** Pipe Seal Cond: **Unknown**

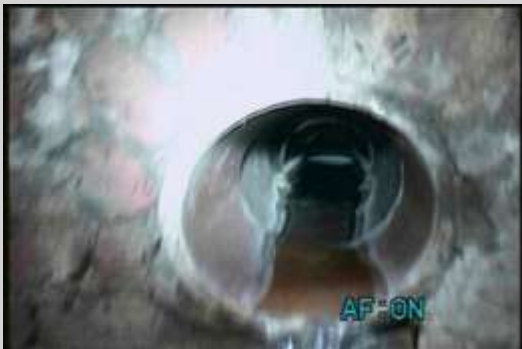
6 O'Clock Inflow

8 in. Circular Gravity Sewer  
Pipe In @ 6 O'Clock

Pipe Material: **Clay** ☐ Pipe Lined

Invert Depth: **5.10** (ft.) Flow Characteristics: **Fast**

Deposits: ☒ None ☐ Mud ☐ Sludge ☐ Debris ☐ Grease

Infiltration: **None** Pipe Seal Cond: **Unknown**

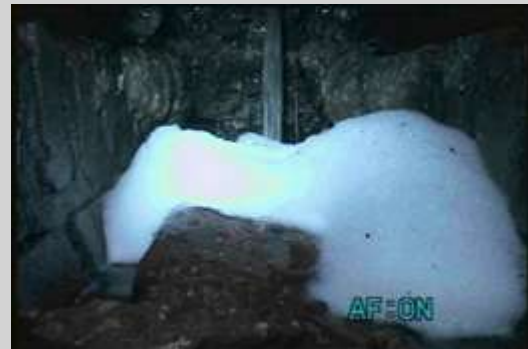
Drop In @ 6 O'Clock

Drop: **Outside Direct**

Drop Condition: **Clogged**
